NC DEPARTMENT OF  
**HEALTH AND  
HUMAN SERVICES**

April 11, 2025

RE: Technical Assistance - Tarheel Army Missile Plant Site Evaluation of Potential Surface, Groundwater, Soil Contamination and Vapor Intrusion (VI).

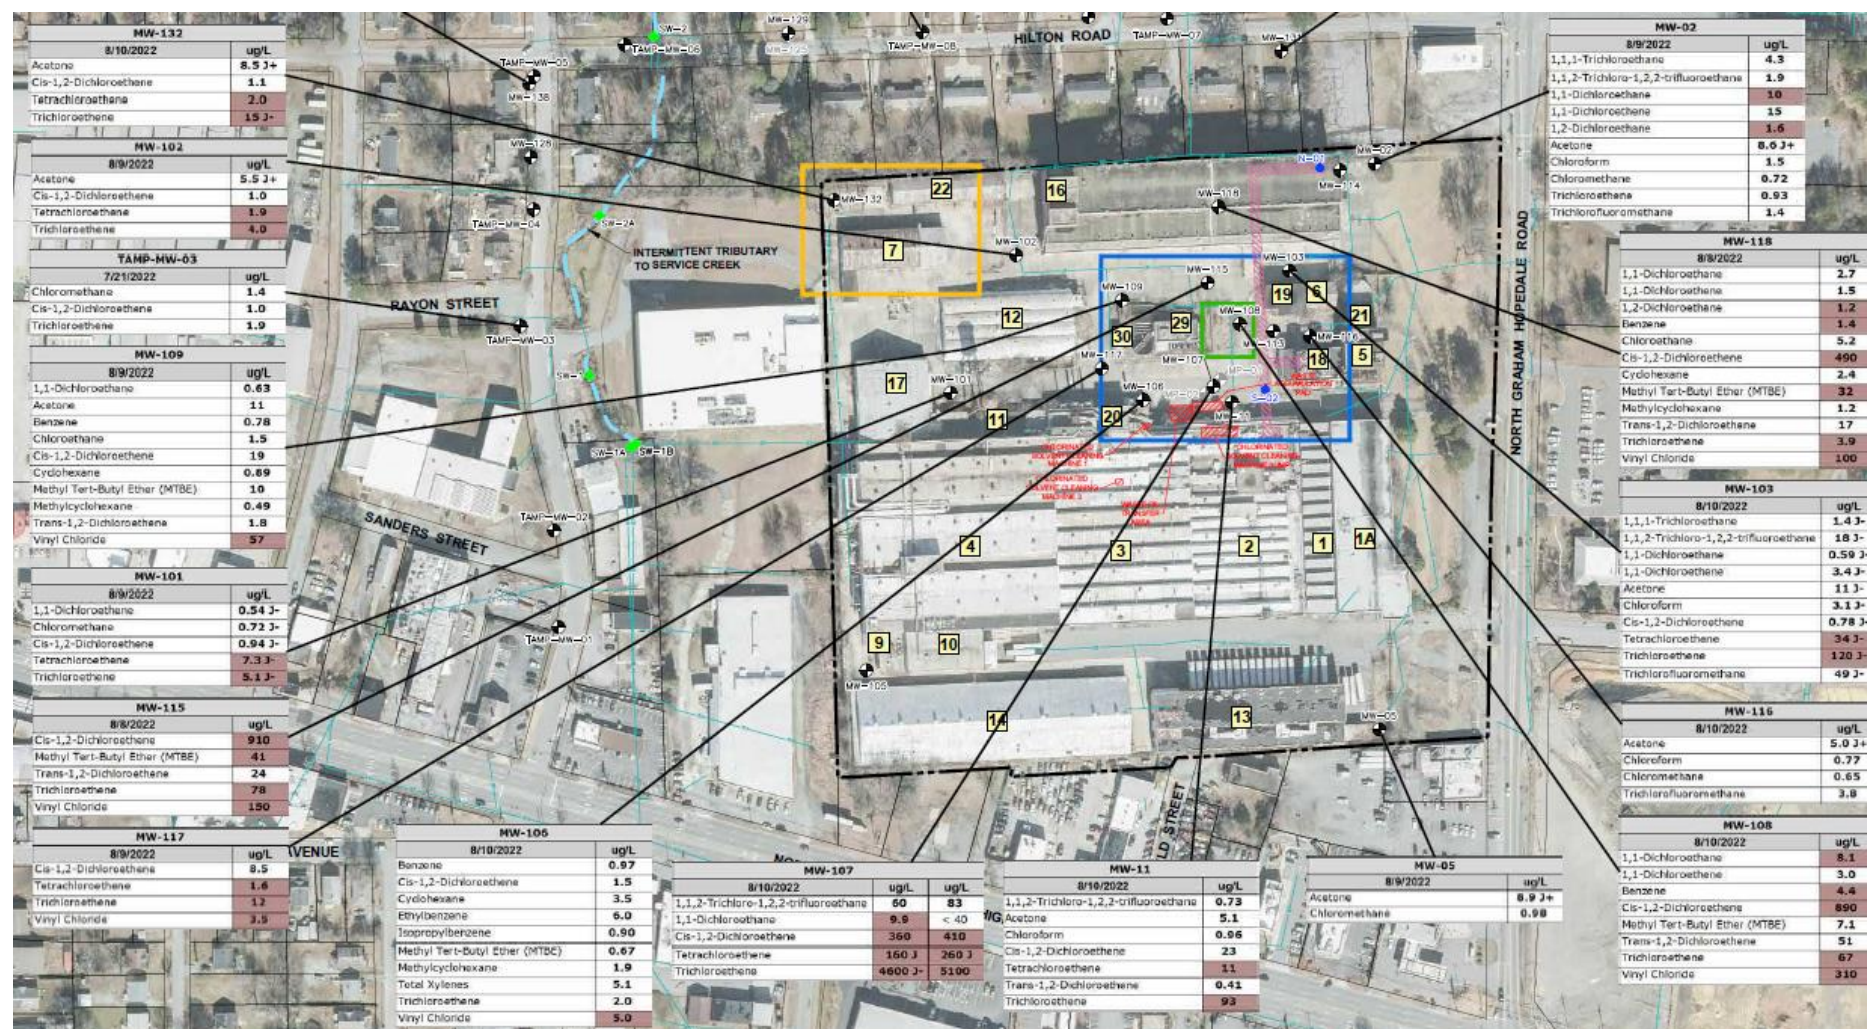
2. **Ongoing Site Contamination.** The report<sup>3</sup> made it clear that the TAMP site itself contains heavily contaminated water beneath the facility. This is best depicted in **Appendix A, Figure 1**. Monitoring wells from multiple sites within the TAMP site shows a wide range of VOCs present over a wide range of concentrations. These VOCs include 1,2 dichlorethene, MTBE, trichloroethene and vinyl chloride, among others, many of which exceed the NC 2L standards. Other VOCs are also present, including known carcinogens (benzene as one example), that may or may not, depending on the MW location, exceed a 2L standard<sup>17</sup>.

Figure 1. Monitoring well VOC measurements obtained from selected sites within the TAMP.

2. Ongoing Site Contamination. Numerous data sets confirm that the TAMP site is clearly contaminated with several volatile organic compounds (VOCs) including, but not limited to, TCE, benzene, 1,1-dichloroethene, tetrachloroethene and 1,4-dioxane. Per- and polyfluoroalkyl substances (PFAS) were also reported in ground water and soil. **HACE recommends that a comprehensive site remediation plan be developed that addresses the cleanup and disposal of contaminated soil, water and other contaminated material on the site itself, with special consideration given to the secondary public health effects to the public, such as aerosolization of contaminated soil and dust, that cleanup efforts may contribute to downgradient contamination outside of the physical boundaries of the TAMP facility.**

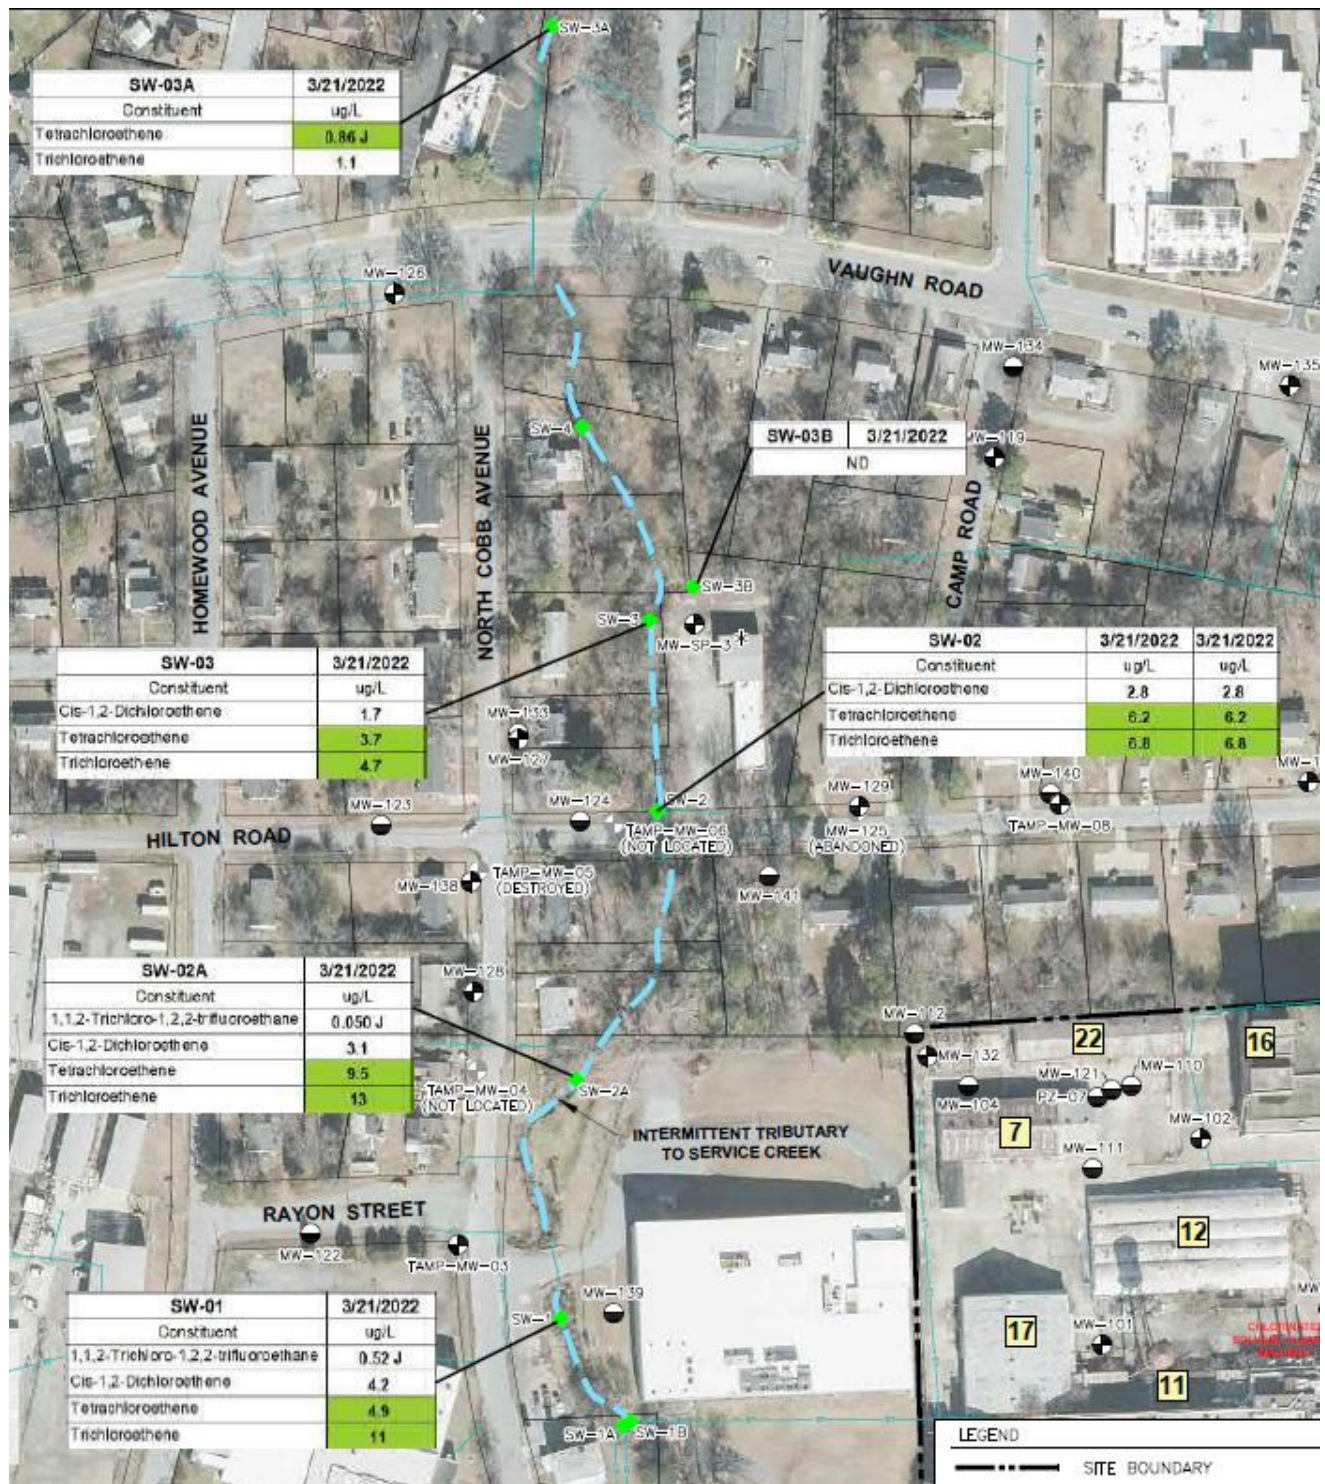
Specifically, this creek was found to contain surface water VOCs during all three seasons of the year, generally highest at the SW-02A collection point, in particular tetrachloroethene and trichloroethene, concentrations of which exceed the 2B water standard, shown in green. The concentrations of VOC tend to decrease in the surface water samples to the north and south of SW-02A but are still present. The report noted that the topography of the land from the western side of the site slopes down from the TAMP site and that groundwater tends to run in both northern and western directions from the TAMP site. The topographic features coupled with the VOC data collected from this creek support the conclusion that surface water runoff from the contaminated TAMP site and/or groundwater moving from the TAMP site are likely sources of the VOC contamination in the creek and reasonably increase the likelihood of potential VI issues on properties near the surface water source with a potential public health impact.

**Figure 2.** Representative VOC data collected from the Intermittent Tributary to Service Creek surface water source. Green indicates the exceedance of the NC 2B water standard.

3. Offsite Surface Water Contamination. Data collected shows that downgradient surface water impacts from VOCs and PFAS chemicals have exceeded the NCAC 02B.0202 Water Quality Standards for Surface Waters (2B Standards)<sup>17</sup> and the USEPA Nationally Recommended Water Quality Criteria for Aquatic Life and Human Health.<sup>18</sup> VOCs and other contaminants have likely been moving off site via the northwest surface water for years<sup>16</sup>. This is likely due to either surface water/stormwater runoff from the site and/or movement of contaminated groundwater from the site to nearby downgradient surface water. **HACE recommends that a comprehensive remediation plan be developed that addresses the removal of the source of contaminated soil and other materials contributing to downgradient surface water contamination.**

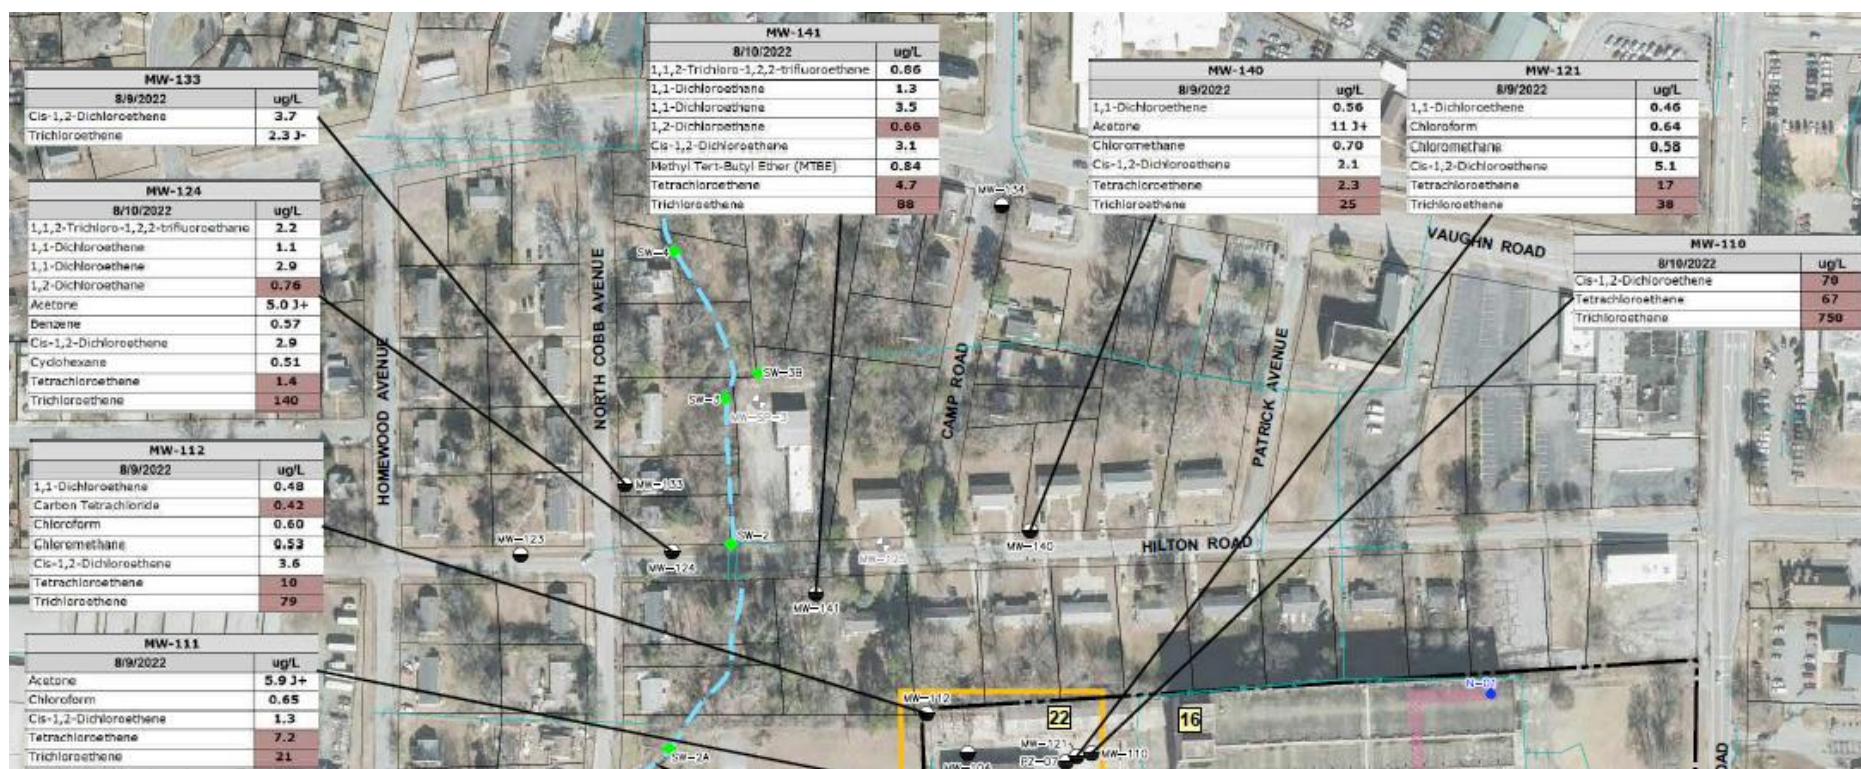
There are two important features to note in **Appendix A, Figures 3 and 4**. First, the well monitoring data points collected north of Hilton Road and west of North Cobb Ave do have some VOCs above the 2L standard from water obtained from the saprolite aquifer layer of the same variety as the VOCs reported in the groundwater sampled on the TAMP site itself. It was also observed that the water samples obtained deeper into the bedrock aquifer also contain several VOCs that exceed a 2L standard. The available data suggests that most of the VOC contamination lies deeper in the bedrock aquifer and is likely to follow the groundwater flow to the north and

Second, it should be noted that most of the MWs are located within the TAMP site itself. Relatively few MWs are located to the north and west of Hilton Road and North Cobb Ave, respectively. The lack of MW data north of Hilton Road and west of North Cobb Ave makes it difficult to determine with any certainty that VI is a public health issue in the homes north and west of the TAMP site. The data is suggestive, but not conclusive, that VI may be a public health issue in these homes for an unknown distance from the TAMP site borders.

**Figure 4.** VOC results of groundwater samples in the bedrock aquifer zone. Red indicates the exceedance of the NC 2L water standard.

- a. **A monitoring well (MW) plan should be developed that will delineate the extent of a potential VOC plume from the nearest TAMP property line. These additional MWs should at least be placed on properties to the north, northwest and west of the site boundaries to determine if groundwater contamination of volatile organics and PFAS chemicals can be detected. The data can be used to demonstrate any chemical contamination above the NC 2L limits and assess any potential public health impacts.**

- b. **If subsurface VOC concentrations are found to exceed applicable 2L standards, VI in the surrounding homes should be considered and evaluated. HACE recommends that the ATSDR guidance<sup>14</sup> and DEQ guidance<sup>13</sup> be followed.**

- c. **Should monitoring well VI and/or PFAS chemicals be found as an issue in areas surrounding the site, a monitoring and remediation plan and engineering controls (i.e. subsurface/sub slab depressurization system for VOCs) should be developed and implemented (per ATSDR and DEQ VI guidance) in conjunction with a health communication plan to inform residents on these properties of the health risks associated with VI in their homes and the strategies necessary to mitigate risks until fully remediated.**

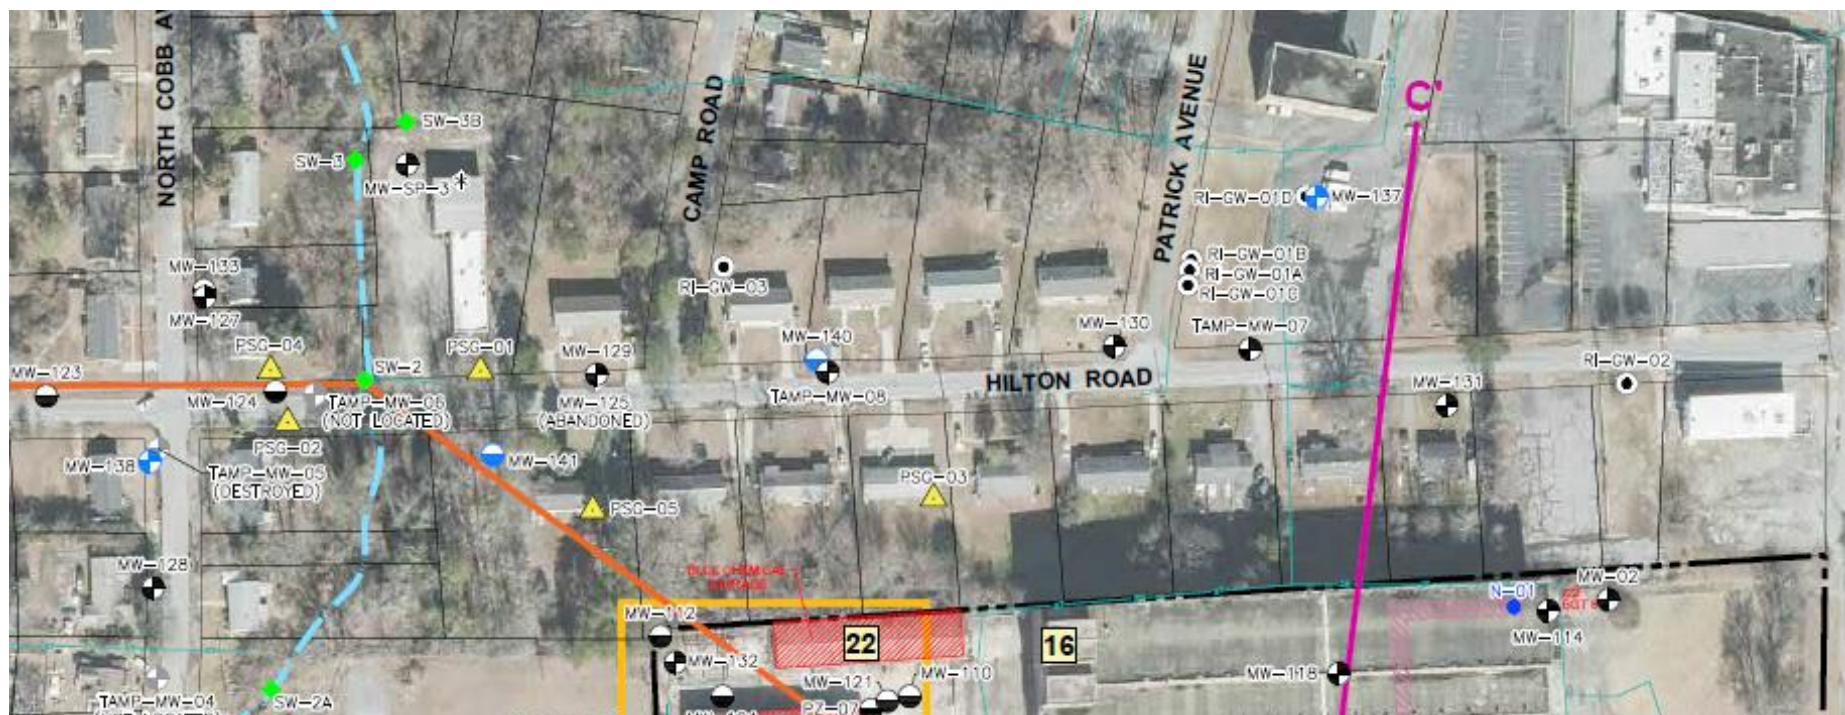
Toluene and Total Petroleum Hydrocarbons (TPH) in the C10-C15 chain link length was reported on PSG-1 and PSG-5, respectively. The data suggests that there is little if any VOCs being emitted from the soil at the sample collection points. However, PSGs were not placed further north and west of TAMP facility where residential houses are located, and no samplers were placed in proximity to the Lucent Technologies facility where a plume is thought to exist. In addition, the report noted that if future VI samples are to be collected, summa canisters (in lieu of passive Beacon samplers) be used. This recommendation was based on greater data quality by summa canisters analyzed by Method TO-15, as compared to Beacon samplers analyzed by USEPA Method 8260C. It was also noted that data from the PSGs reported in 2020 saw a greater number of constituents during the soil-gas sampling events in August 2017, February 2019, and April 2019, as compared to the limited number of constituents (i.e., only toluene and TPH C10-C15) detected in July 2022 using Beacon samplers. It was also noted that passive samplers may not be favored according to the North Carolina guidance<sup>13</sup>, which states that passive samplers may be used when shallow soil contamination or groundwater is present at less than 5 feet bls and are "limited to field screening only during the investigation of the VI." In summary, the placement and type of the samplers used in the report were likely not sufficient to determine the risk of VI in residences north and east of the TAMP site.

**Figure 5.** Graphical representation of Passive Soil Gas (PSG) sampler placement (yellow triangles) in relation to the TAMP site northern boundary (dotted black line).

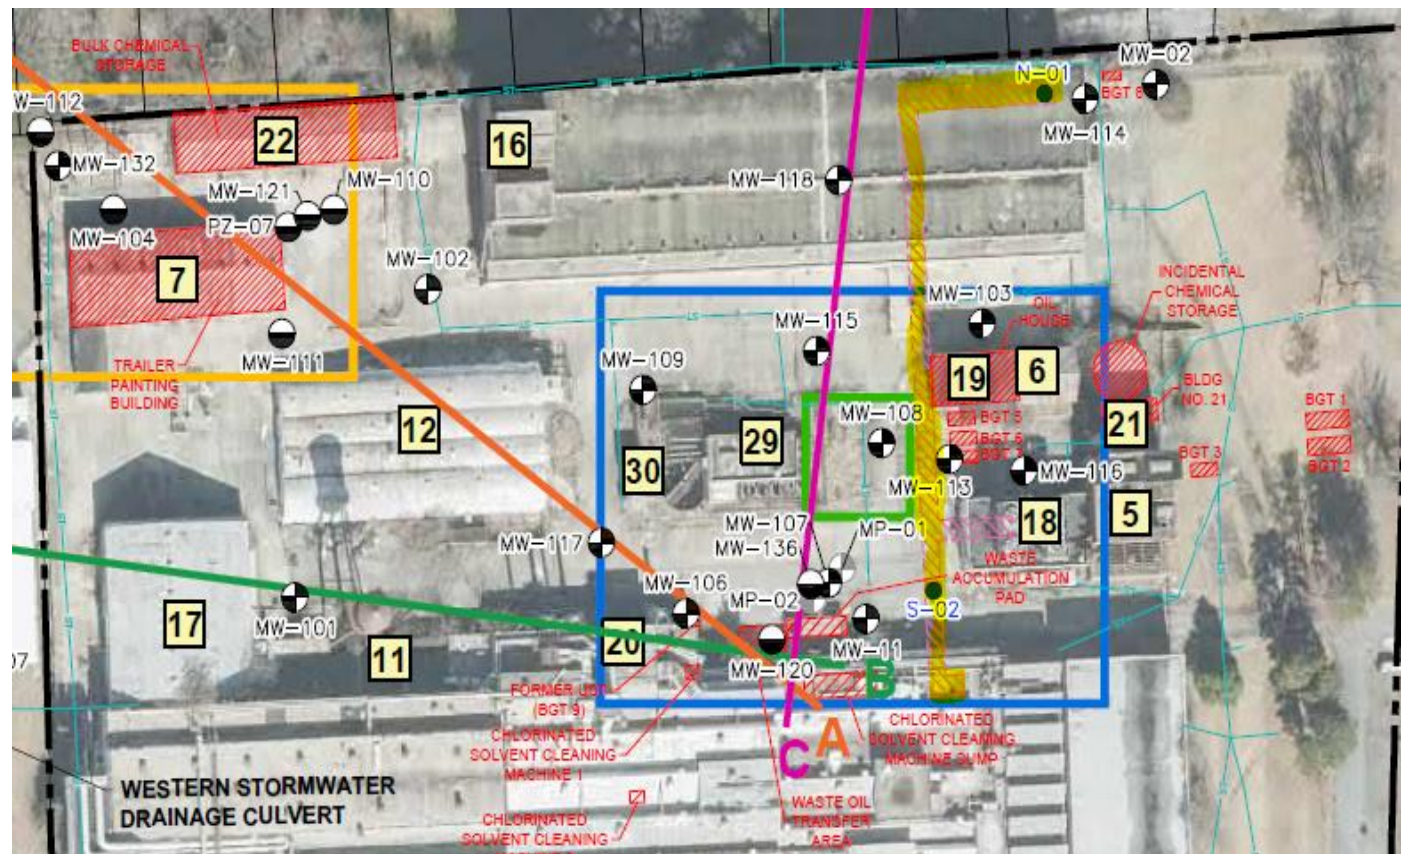
NC DEQ VI Guidance.<sup>13</sup> states that all preferential pathways (utility and sewer beds, stormwater structures, and other unknown links offsite) should be evaluated. As shown in **Appendix B Table 4**, two sites containing free standing water in the tunnel (one on the north side and one on the south side) were sampled (labeled N-01 and S-02) with several VOCs detected. Tetrachloroethene and trichloroethene exceeded the 2B surface water and wetland standards. Air samples in the tunnels were not reported as sampled or reported.

**Figure 6.** Schematic of the northern and central areas of the TAMP facility showing water samples from On-Site Tunnel.

5. Comprehensive Delineation of Nature and Extent of Known and Unknown Subsurface Structures and Preferential Pathways On and Offsite. The known underground tunnel on the TAMP site is potentially contaminated with VOCs (and likely PFAS chemicals) because of contaminated ground water migrating through contaminated soil and water above or adjacent to the one known underground tunnel on the site. **HACE recommends that this known tunnel be remediated, and the surrounding soil and groundwater be remediated as part of a comprehensive site remediation plan.**

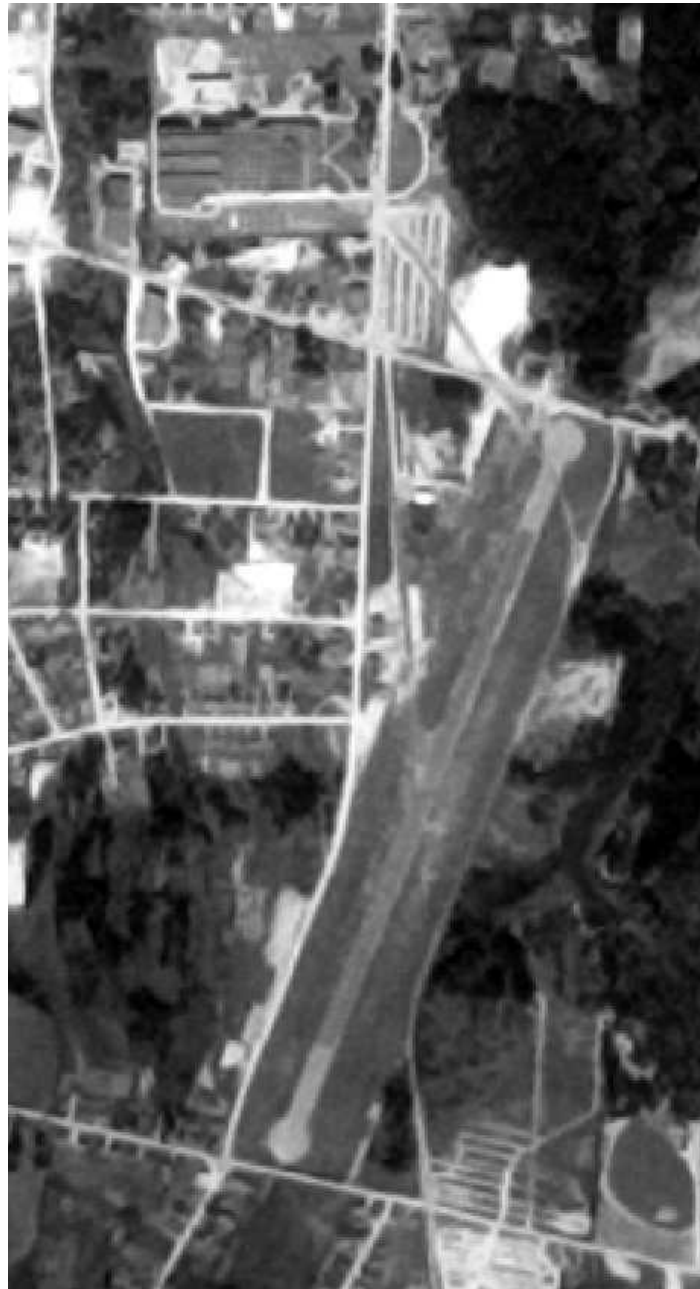
Historical records indicate an airstrip near the TAMP facility did exist. What remains of this airstrip is not easily identified today using Google Maps. However, publicly accessible websites have some useful information regarding what was likely the Huffman Field/Fairchild Field in Burlington, NC<sup>7,8</sup>. Figure 7 shows what this airfield looked like circa 11/18/1950 on a USGS aerial view. The photo depicts Fairchild Field as having a single paved northeast/southwest runway, with a ramp & some small buildings on the northeast side, and the former Fairchild aircraft factory (now known as the TAMP site) across the street to the northwest (upper left portion of the photograph) from the airfield. It is possible that an underground tunnel existed or still exists and that was likely used to move equipment and/or personnel from the TAMP site to the airfield in a secure manner and not having to interfere with the flow of traffic to access either site. This area now appears to have several businesses built over where this airstrip used to be located. The potential public health impact of these tunnels and/or the chemical contents of this tunnel is unknown.

**Figure 7.** Aerial view of Huffman Field / Fairchild Field in Burlington, NC, circa 1950.

**HACE also recommends that further investigations be conducted to conclusively determine if a second and longer tunnel that runs north to south from the TAMP site to properties to the south of the TAMP site exists today.** This investigation should also include other possible preferential pathways including sewer lines, underground utilities, etc. If a tunnel or other preferential pathways exist, their specific location needs to be identified; and the contents in and around them should be analyzed to determine if further investigation of offsite contamination to the south of the TAMP site and if a public health impact is present. The public health impacts of VI in homes and businesses to the south of the TAMP site cannot be known until the second tunnel and other preferential pathways, if they exist, are better characterized.
